This document: Annex 3 – 6 photographs of Aktau Oil Berths

**Traffic and Feasibility Studies - tnreg 9803**

Module E: Transport of crude oil and oil products on

**Technical report: Evaluation of existing facilities**

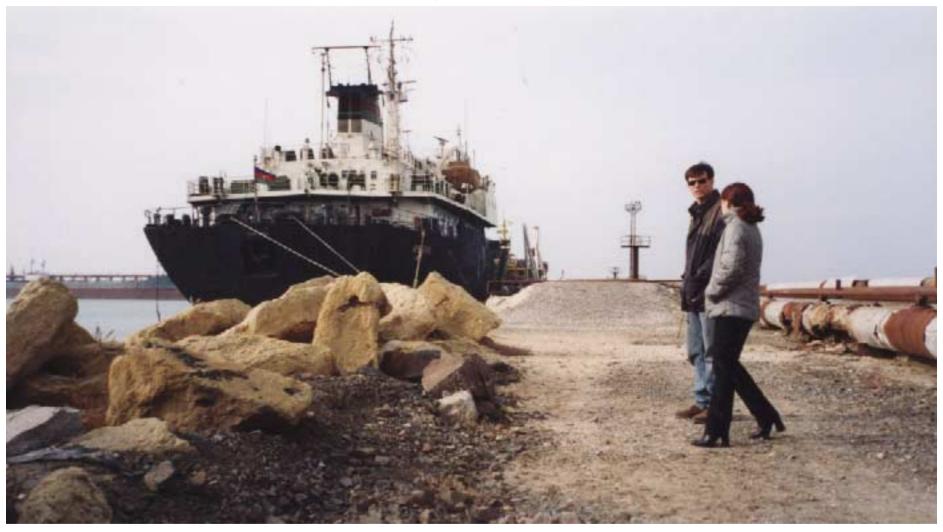
1. Access way to berths n°4 and n°5

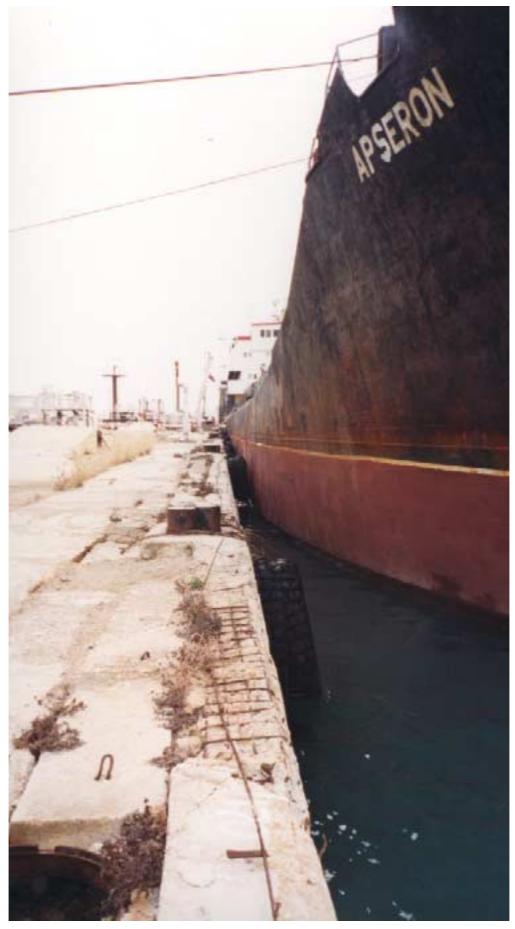
2. Tanker berthed alongside berth n°5 (notice poor piping system)

3. Berth  $\ensuremath{\text{n}^{\circ}5}$  . Details of capping beam, bollards, mooring ropes and fenders

4. Same areas as photo  $\ensuremath{\text{n}}^{\circ}3\,,$  from the front part of the vessel

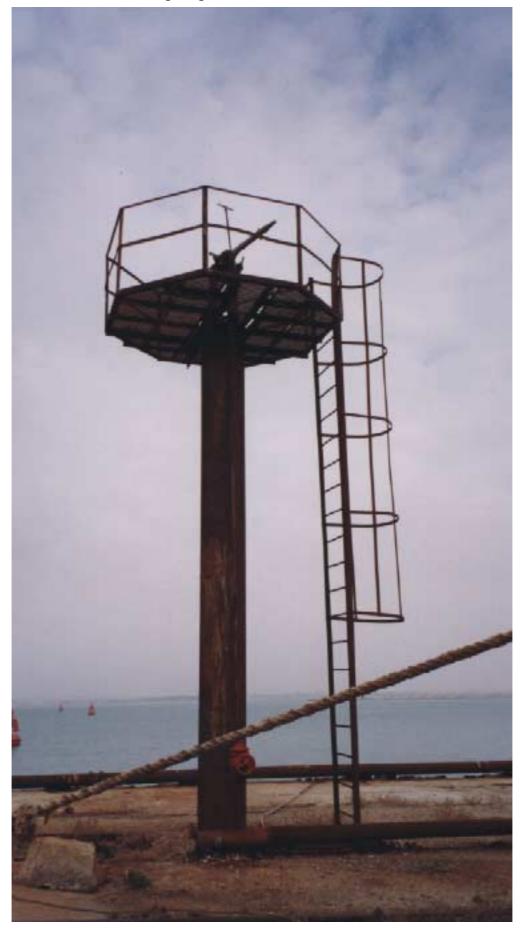
5. Fire-fighting tower between berths  $n^{\circ}4$  and  $n^{\circ}5$

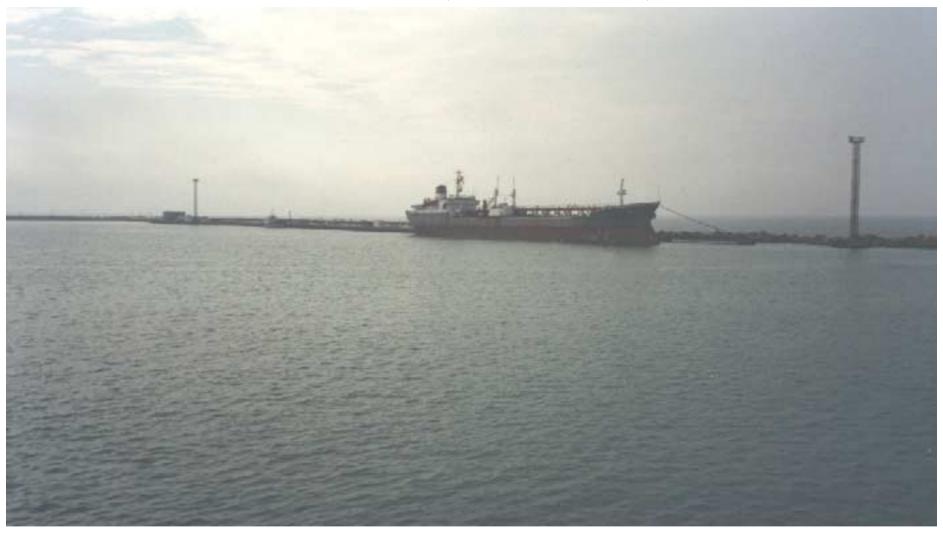
6. Berths n°9 and n°10 (notice low-crested breakwater)
